## Inspection Report

**Madison County/ Jack Hobbs**

110 N Main St  
Madison VA 22727

**Burgess Inspections Inc.**

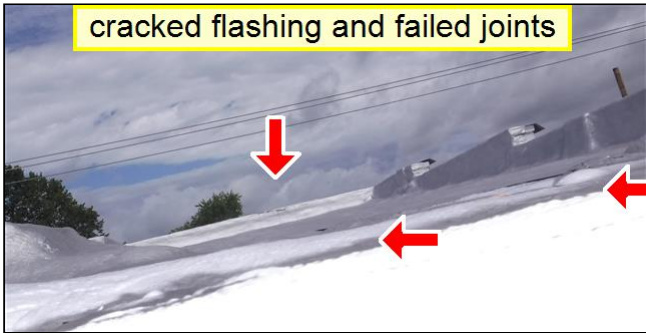
(1) The flat roof has been coated with a white material. There are areas that appear to have failed in the roof coverings. The flashing is also cracked at the front of the building. Recommend evaluation and repair by a licensed roofing company.

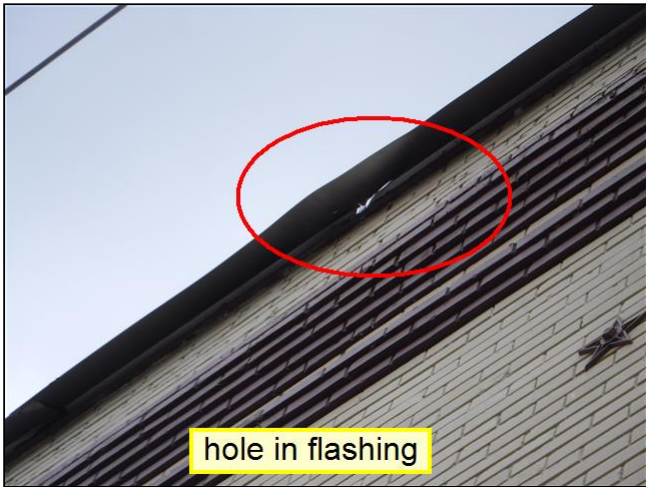
1.1 Item 1(Picture)

The hole in roof flashing as viewed from the ground. Recommend repair by a licensed roofing contractor.

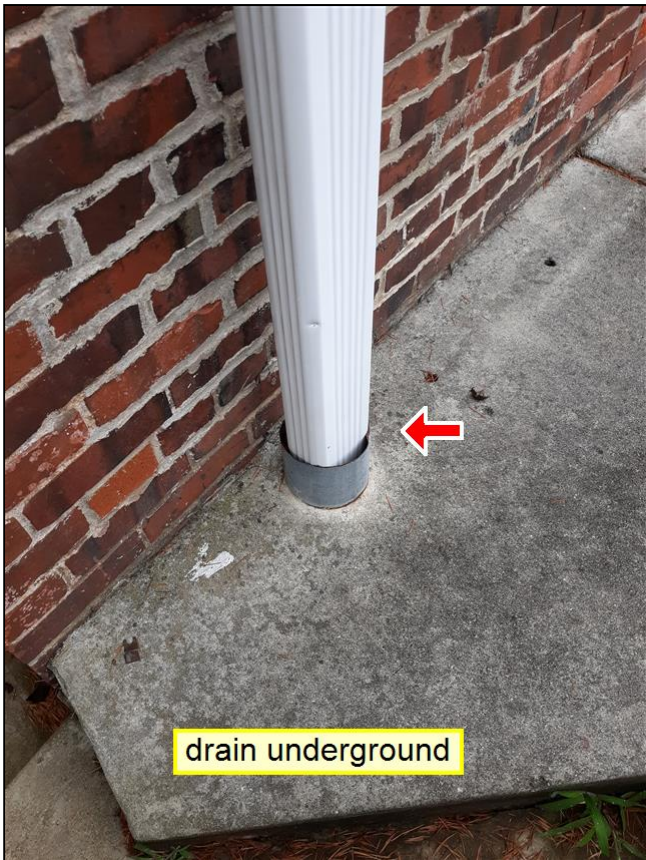
1.3 Item 1(Picture)

(1) Some of the gutters drain underground. It is beyond the scope of this inspection to determine how well they function.

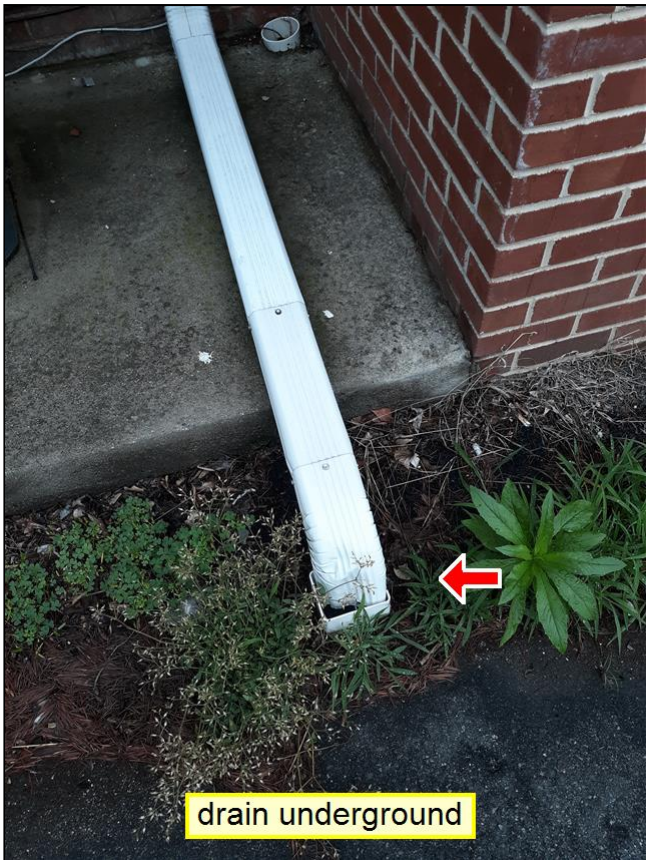
1.3 Item 2(Picture)

(2) As regular maintenance keep gutters and downspouts clear to allow water to flow away from the home.

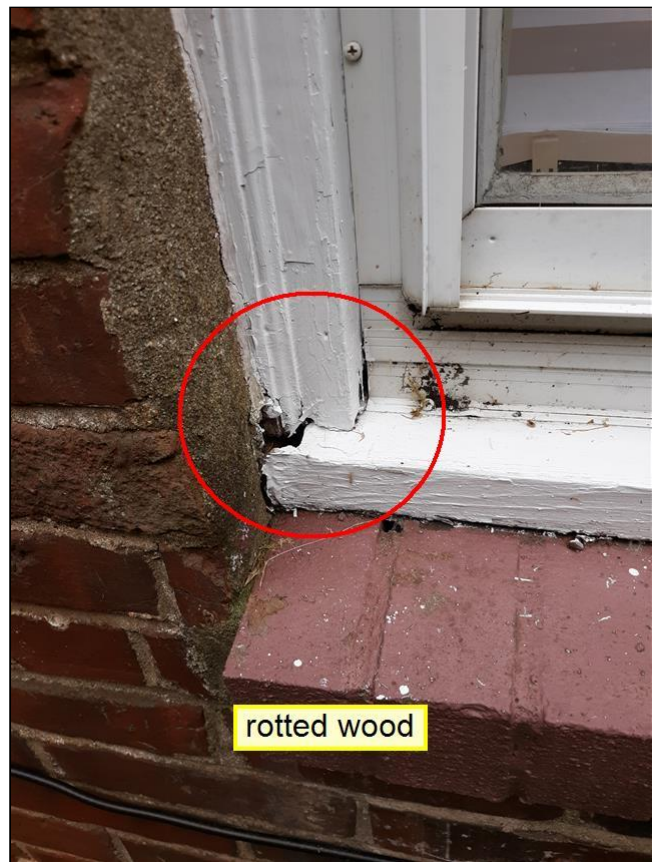
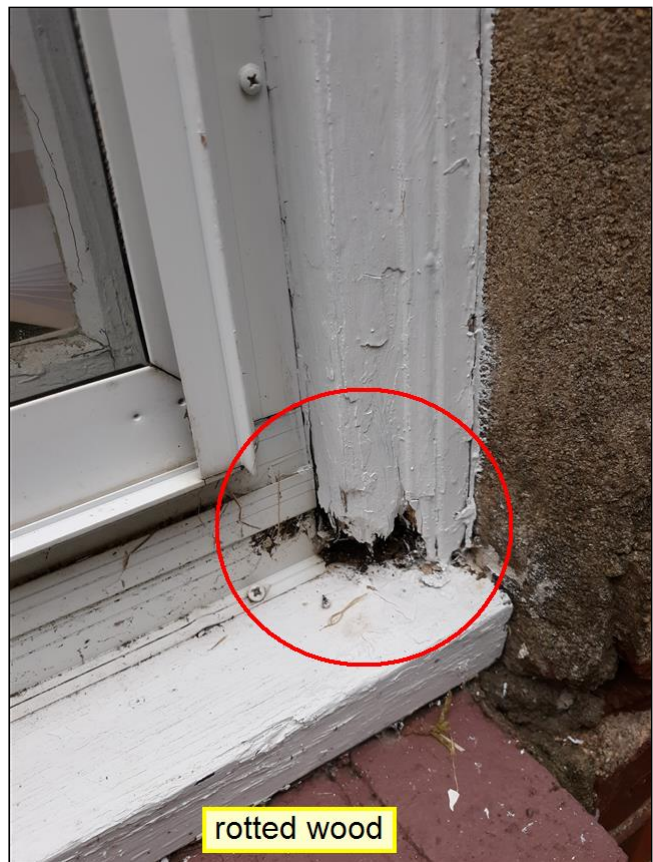
2.0 Item 1(Picture)

(1) There is rotted wood trim and wood siding on the left exterior of the building and the back window. Recommend repair by a qualified contractor in this field.

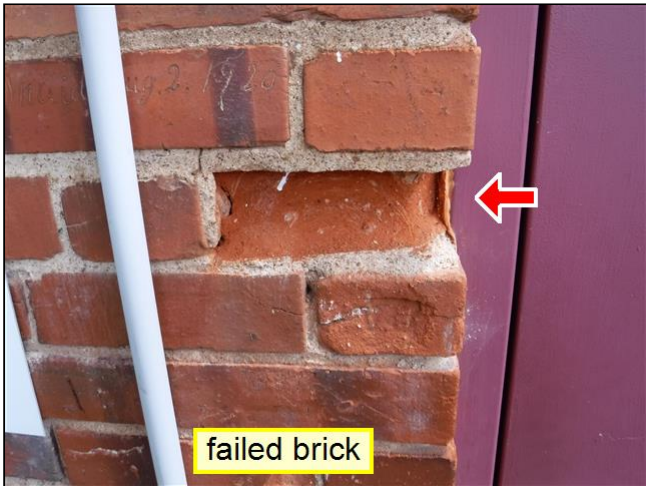
2.0 Item 5(Picture)

(2) There is a failed brick by the side door. Recommend repair by a qualified contractor in this field.

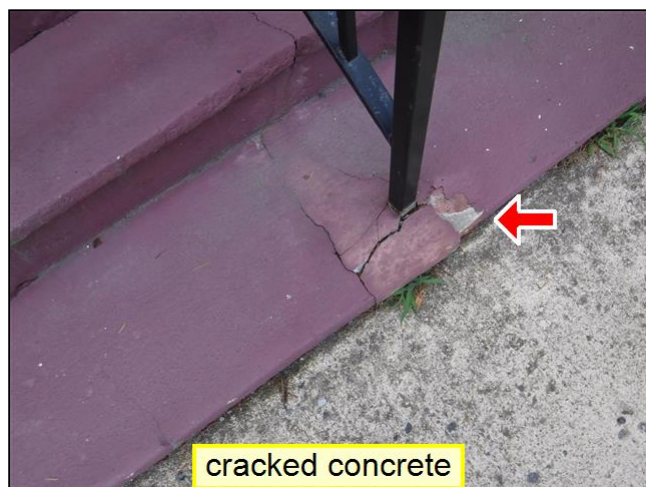
2.3 Item 1(Picture)

- 🏠 There is cracked concrete at the front entrance. Recommend evaluation and repair by a qualified contractor in this field.

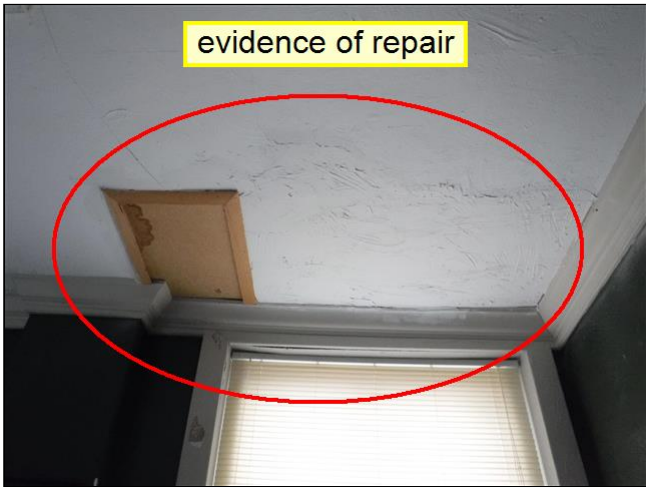
3.0 Item 1(Picture)

(1) There is evidence of a repair in the ceiling. Recommend evaluation and repair if needed by a qualified contractor in this field.

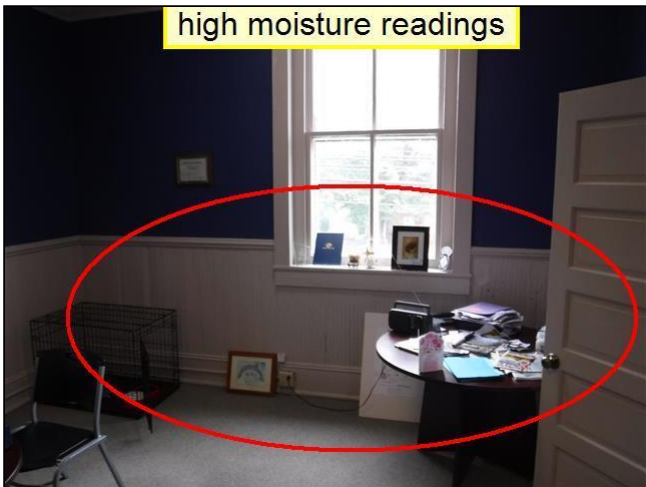
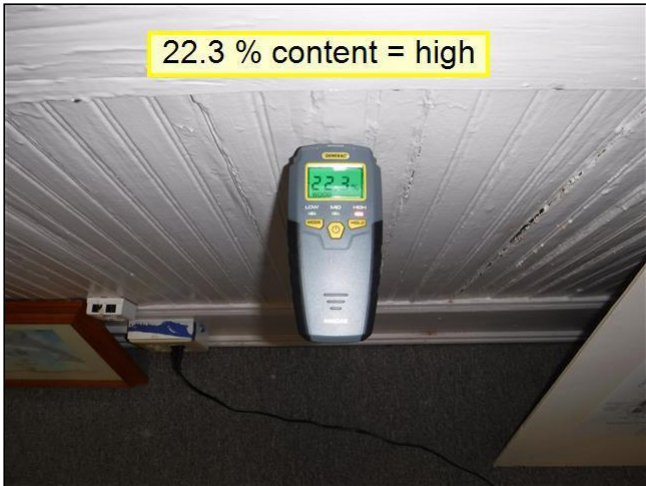
3.1 Item 1(Picture)

(1) The upstairs front wall (main office) has a very high moisture content in the wall. Recommend evaluation and repair by a qualified contractor in this field.

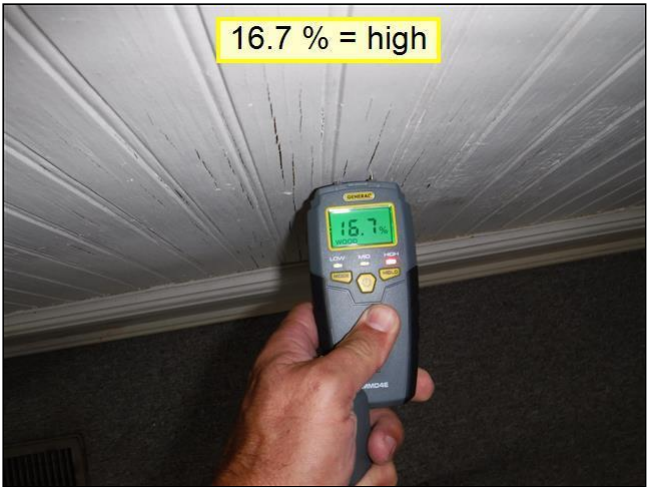
3.1 Item 5(Picture)

🏠 (2) The right side of the building (conference room) has a high level of moisture in the wall. Recommend evaluation and repair by a qualified contractor in this field.

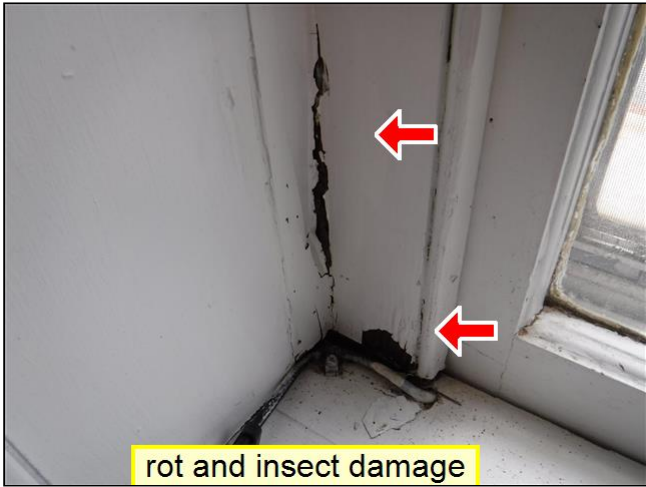
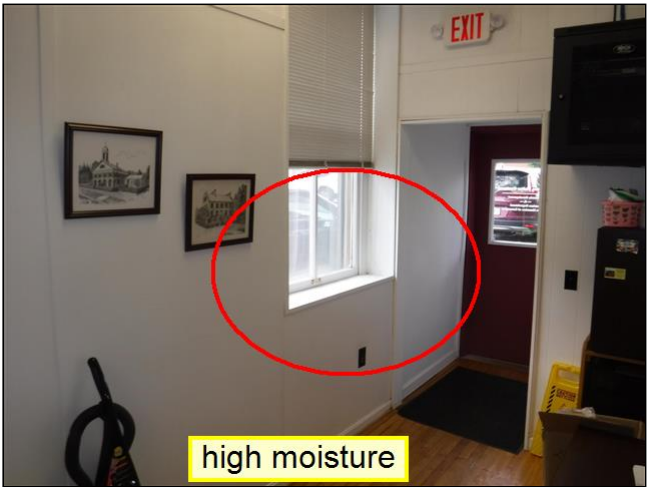
3.1 Item 7(Picture)

🏠 (3) The main floor has two windows at the back with rot and past insect damage. Recommend evaluation and repair if needed by a qualified contractor in this field.

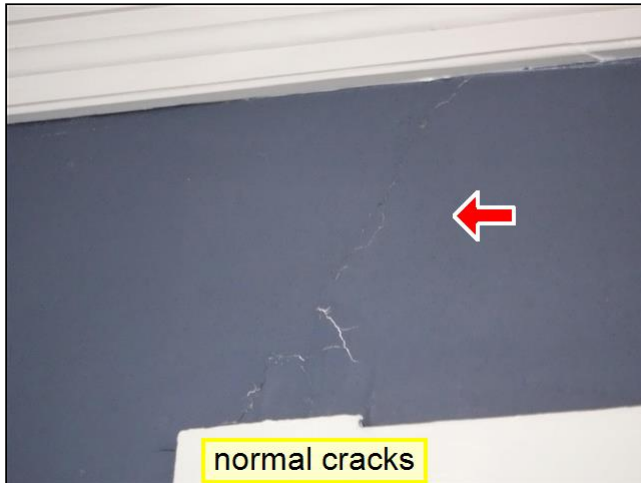
3.1 Item 11(Picture)

(4) There are settlement cracks in the walls. This appears to be due to normal settlement. If you have any concerns we suggest consulting a structural engineer.

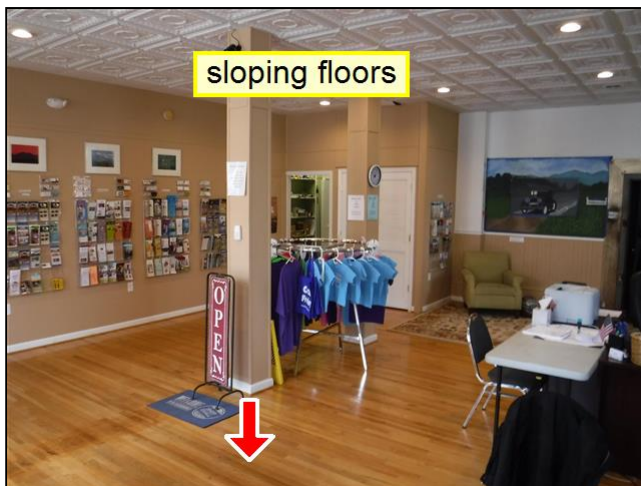
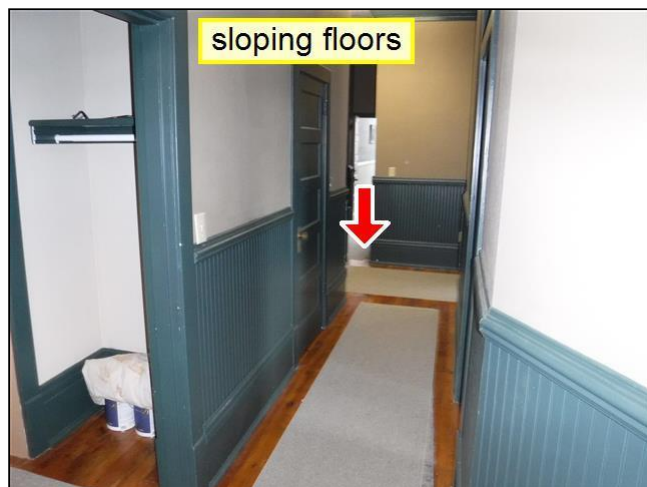
3.3 Item 1(Picture)

Sloping floors were noted, mainly up stairs and the front entrance. This appears to be from settlement or maybe even built this way, but it is beyond the scope of this inspection to determine this. If you have further concerns have a qualified licensed contractor correct if needed.

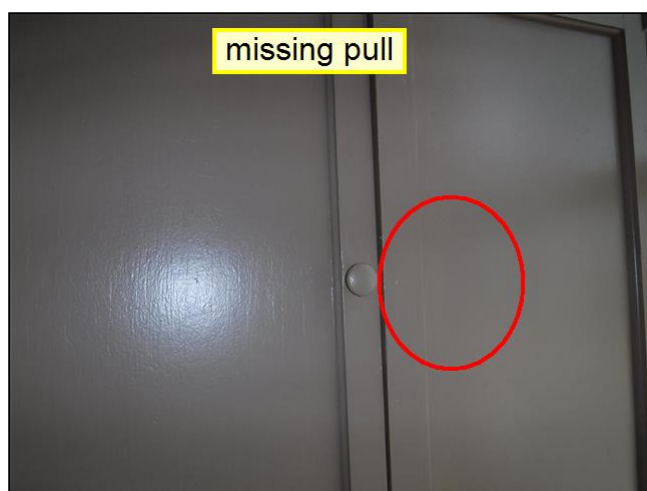
3.4 Item 1(Picture)

One kitchen cabinet is missing a pull. Recommend repair if needed by a qualified contractor in this field.

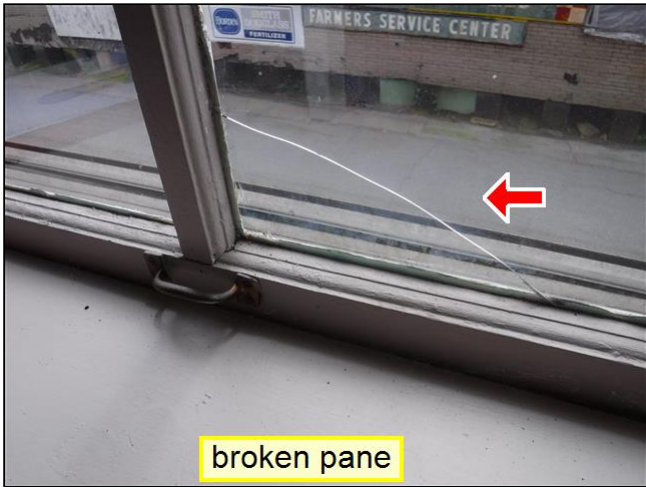
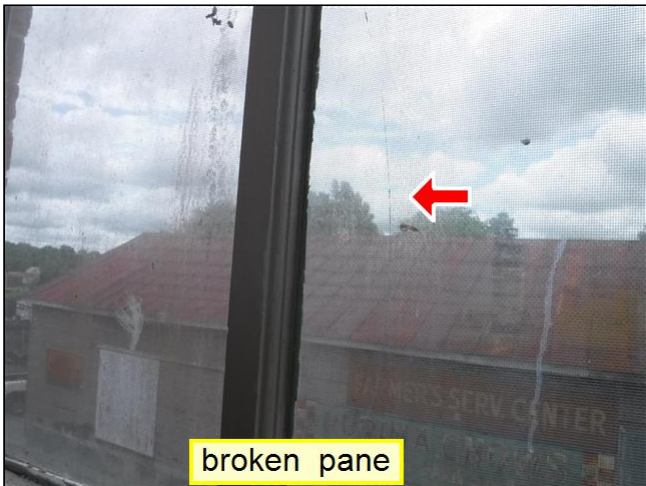
3.6 Item 1(Picture)

🏠 (1) There were three broken window panes noted. These are located in the upstairs back room. Recommend evaluation and needed by a qualified contractor in this field.

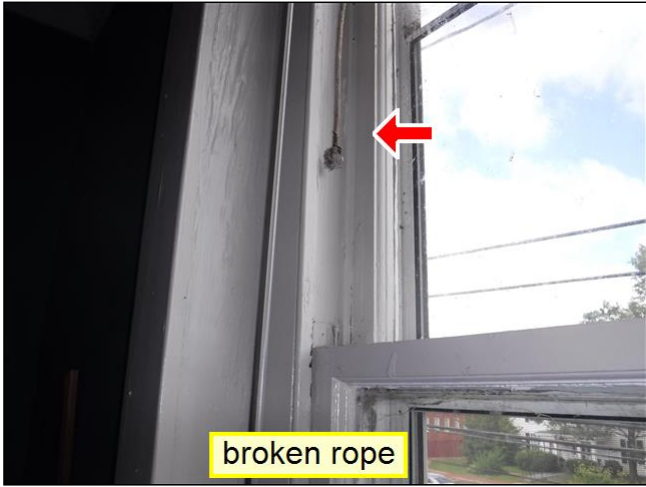
3.6 Item 4(Picture)

🏠 (2) The vast majority of the windows in the building would not open. Many had broken pulley ropes and missing locks. Recommend evaluation and repair by a qualified contractor in this field.

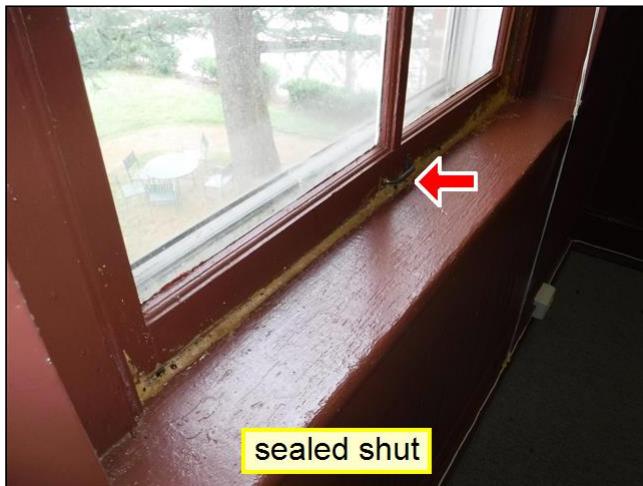
3.6 Item 7(Picture)

(3) The upstairs side room window has been sealed shut. Recommend evaluation and repair by a qualified contractor in this field.

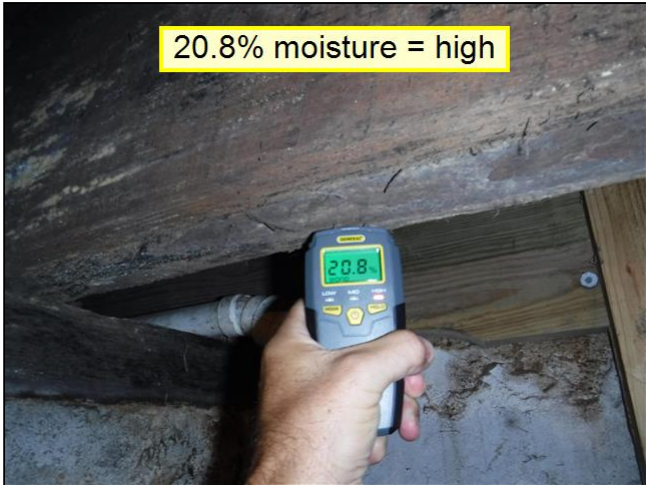
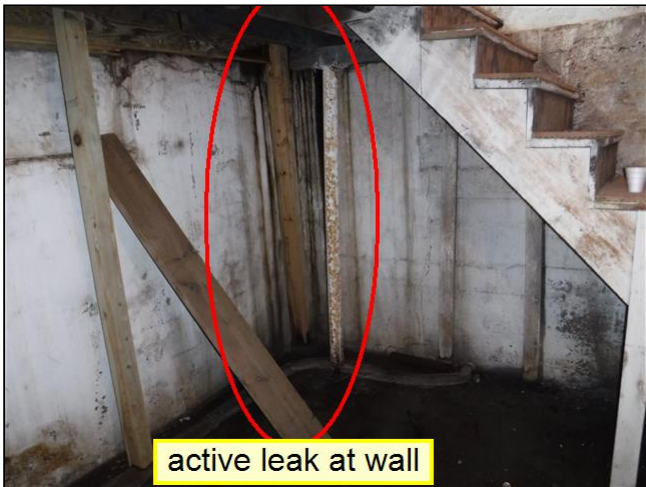
4.0 Item 1(Picture)

(1) There are active leaks in both basement walls. These leaks have standing water on the floors and there is mold or microbial growth present along with high levels of moisture in the joists, girders and walls. Recommend repair by a qualified contractor in this field..

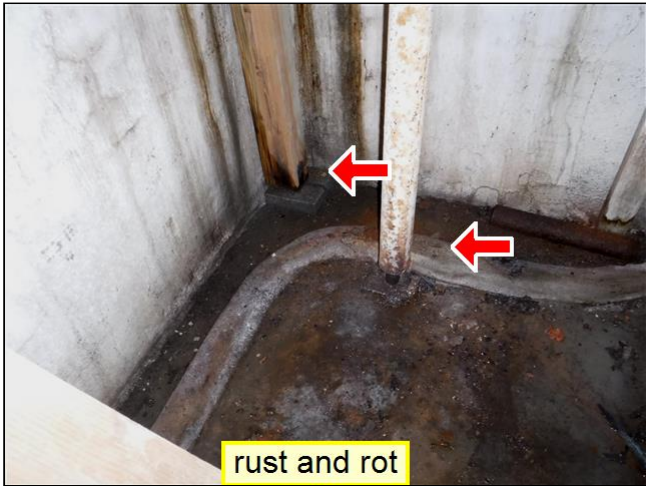
4.0 Item 6(Picture)

🏠 (2) There are many added wood and metal supports in the basements. These are rusting and rotted at the base. Recommend repair by a qualified contractor in this field.

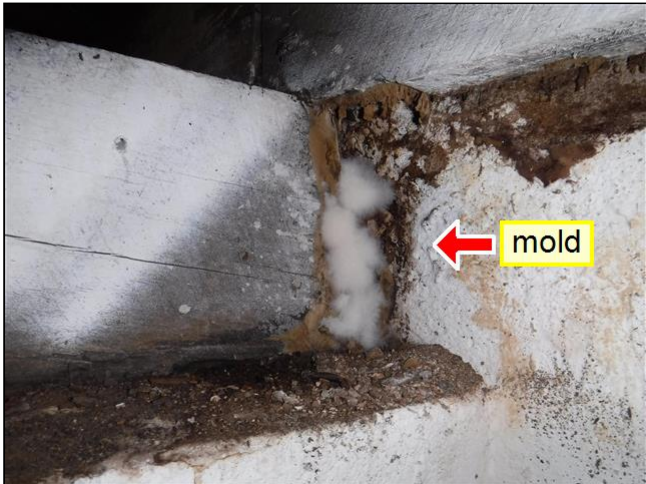
4.0 Item 11(Picture)

(3) Mold growing in the basements. Recommend repair by a qualified contractor in this field.

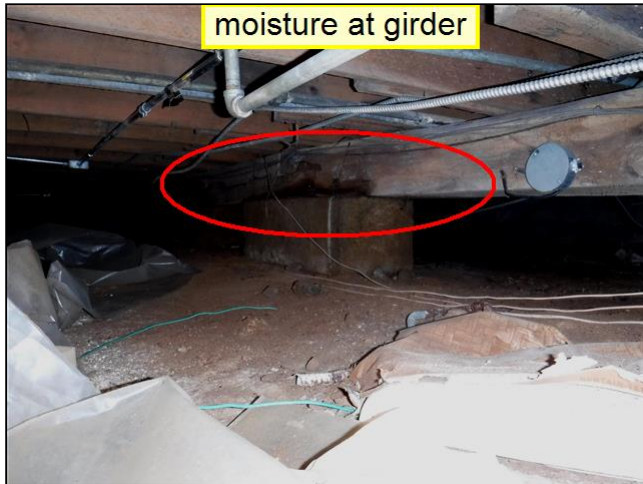
4.1 Item 1(Picture)

(1) There is evidence of moisture at the girder. This may be due to high humidity from the wet basement, but it is beyond the scope of this inspection to determine a cause. Recommend evaluation and repair if needed by a qualified contractor in this field.

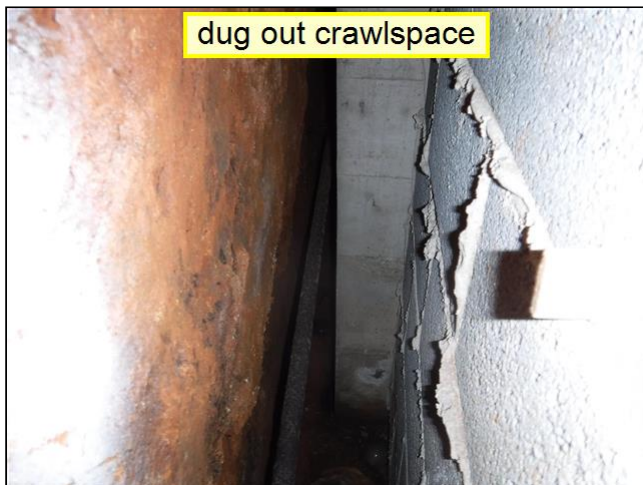
4.1 Item 2(Picture)

(2) The crawlspace has been dug out on the sides. This is for information only.

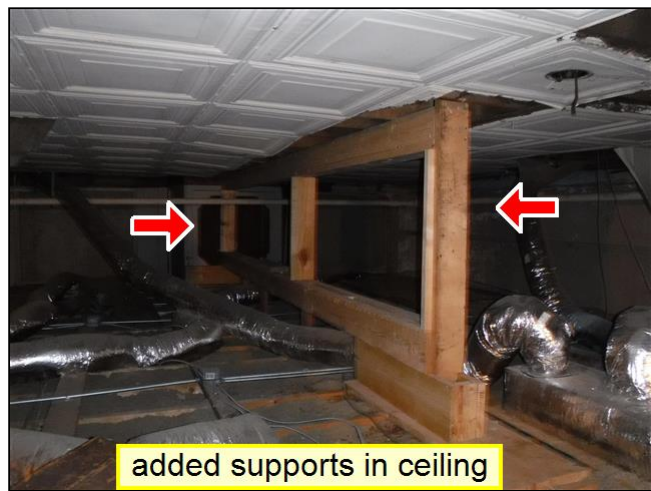
4.6 Item 1(Picture)

There are many added wood supports in the ceiling crawl area. If you have any concerns we suggest consulting a structural engineer.

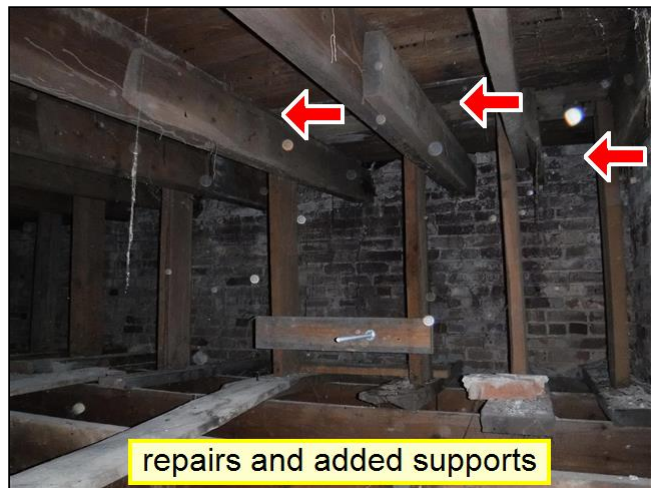
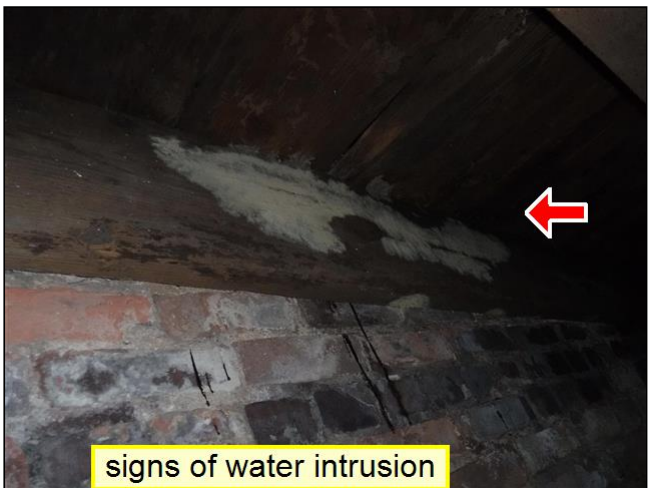
4.7 Item 1(Picture)

(1) There is evidence of repairs and water intrusion in the attic space. This appears to be isolated, but it is beyond the scope of this inspection to determine the exact cause. Recommend evaluation and repair by a qualified contractor in this field.

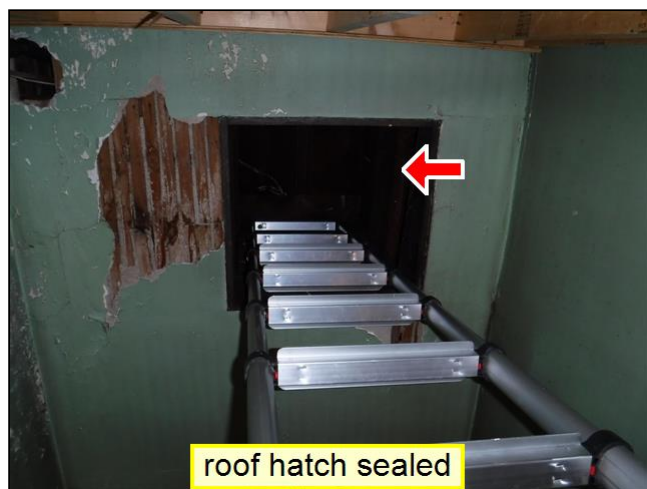
4.7 Item 3(Picture)

- 🏠 (2) The hatch to the roof has been covered over and sealed. I could not get it open and access the roof. Recommend repair by a qualified contractor in this field.

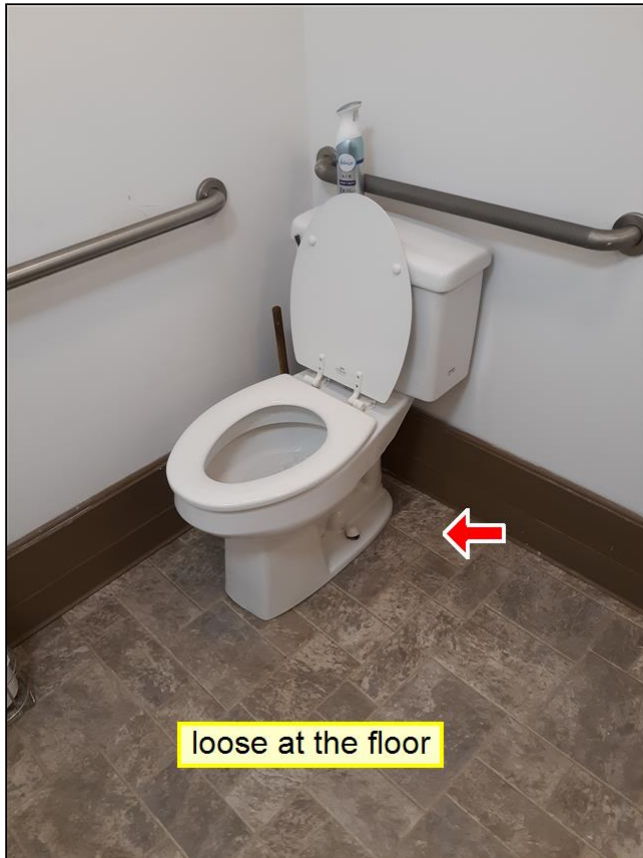
5.1 Item 1(Picture)

(1) The toilet is loose at the floor. Repairs may involve re-setting the toilet on a new wax seal. I recommend a qualified licensed plumber repair or correct as needed.

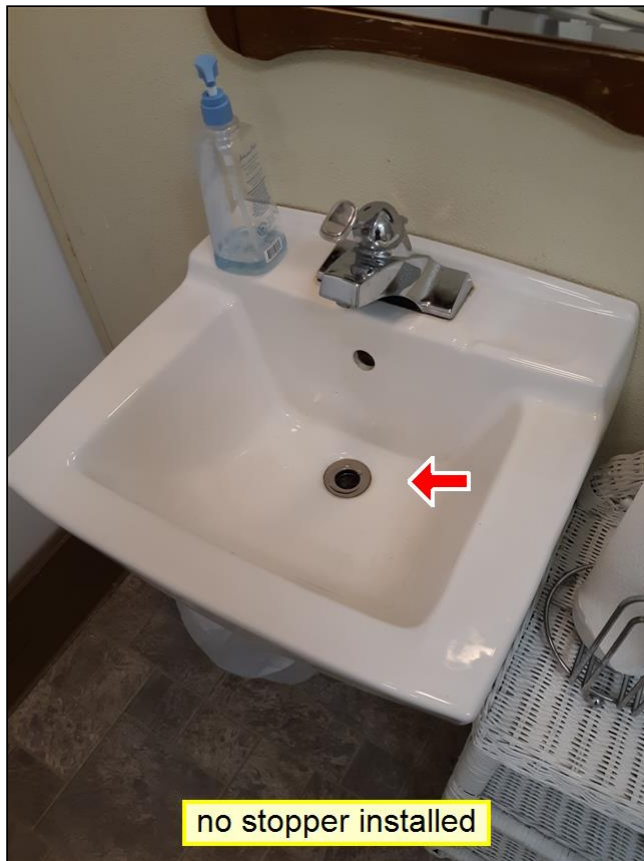
5.1 Item 2(Picture)

- 🏠 (2) The bathroom sink is missing a stopper. Recommend repair by a licensed plumber.

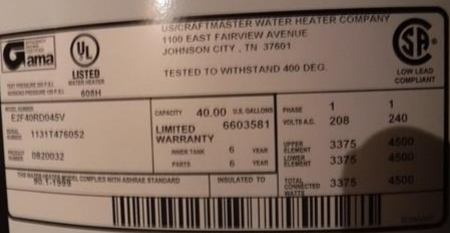
### 5.2 Item 2(Picture)

(2) The 40 gallon water heater is 9 years old.

data plate

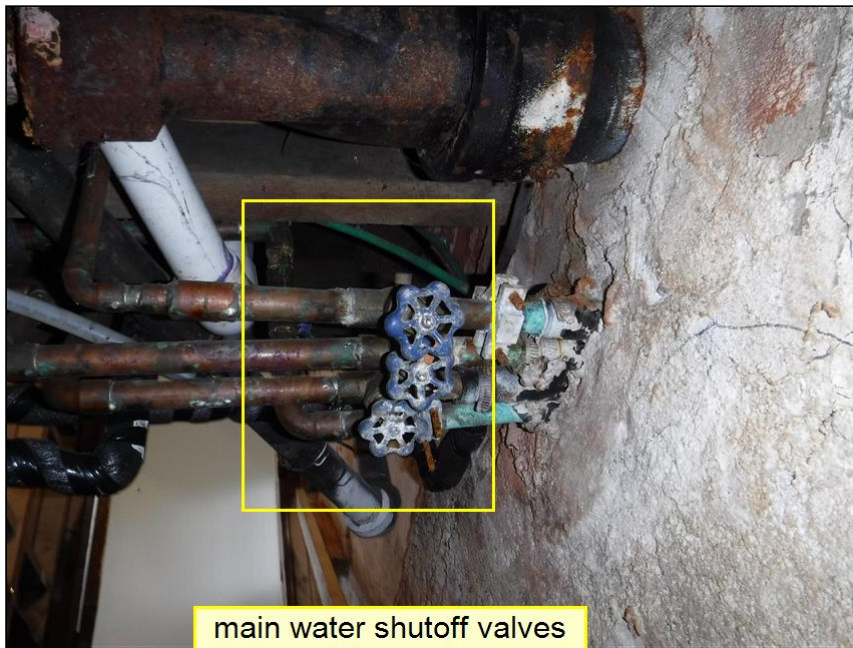
5.3 Item 1(Picture)

The main water shutoffs are in the basement.

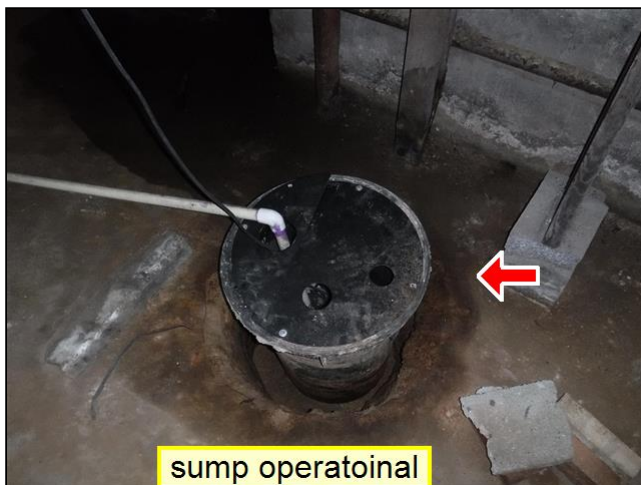
5.6 Item 1(Picture)

There were three sump pumps in the two basements. The sump pumps were tested by raising the float and seeing if they came on. they work at time of the inspection.

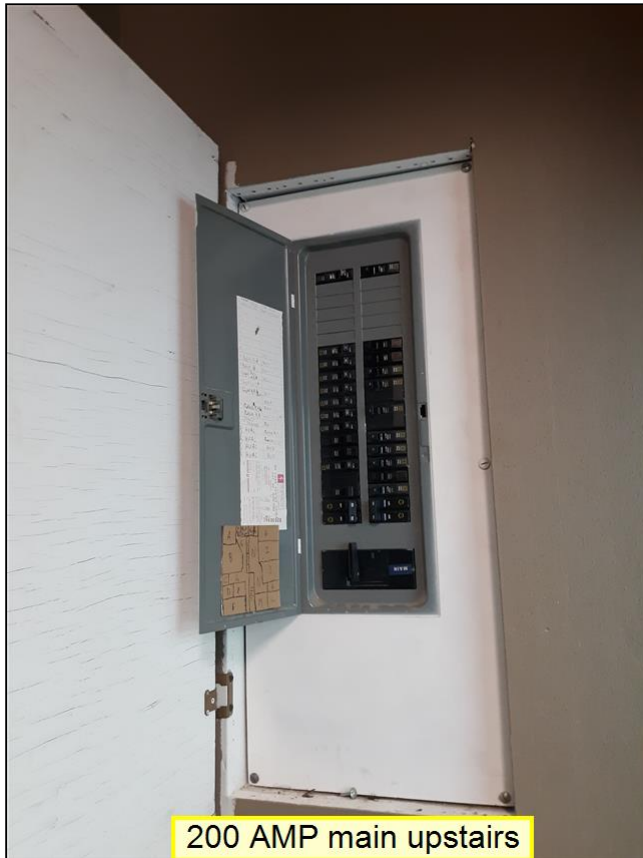
6.6 Item 1(Picture)

(1) The main electric panel is located upstairs at the back of the building and another main panel in the back room of the literacy building.

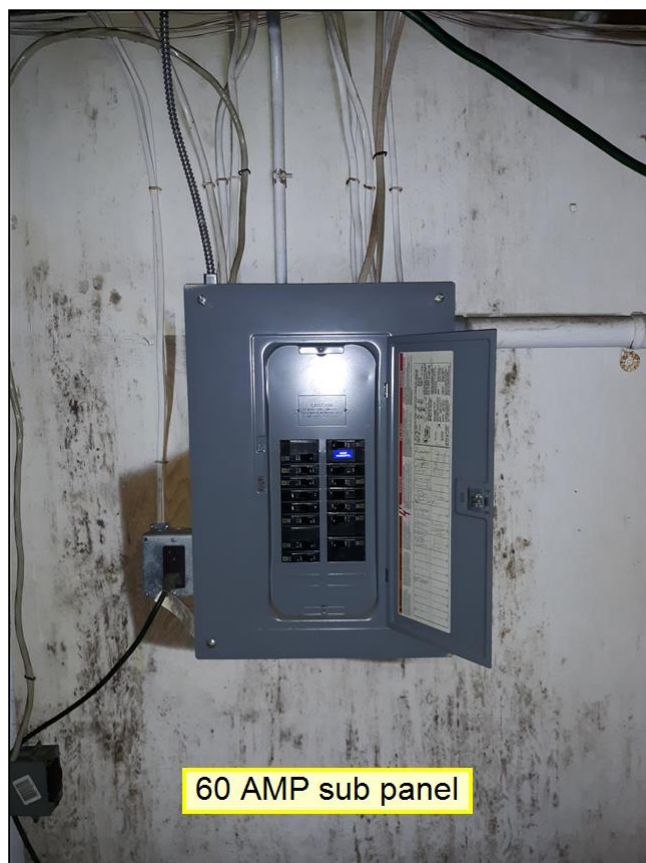
6.6 Item 3(Picture)

(2) There is 60 AMP sub panel located in the basement.

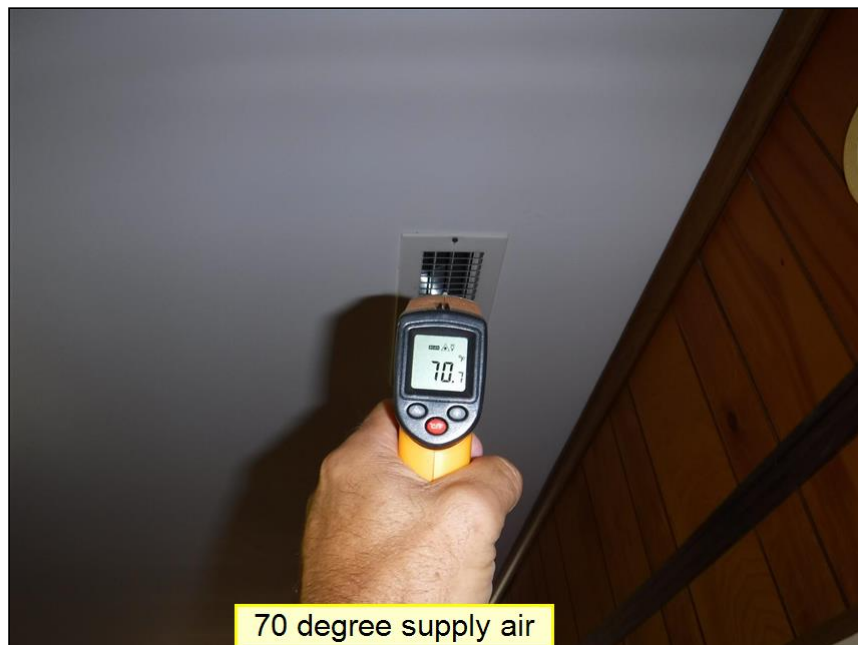
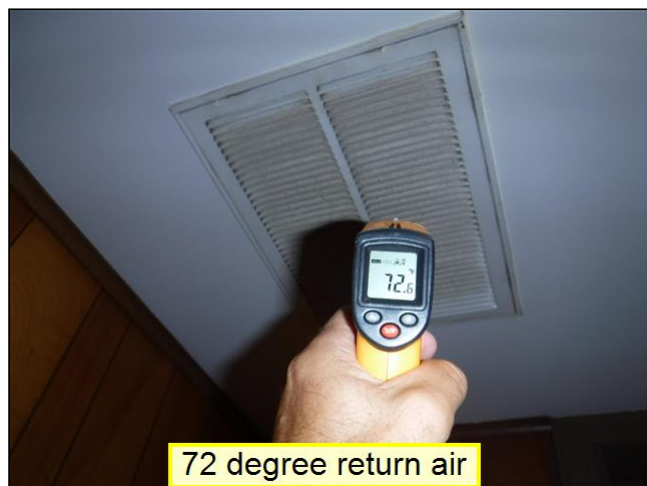
7.3 Item 1(Picture)

- 🏠 (1) The temperature differential between the return air and the supply air was NOT adequate on the AC unit for the Literacy center. The difference should be between 14 and 22 degrees. The temperature difference was 2 degrees

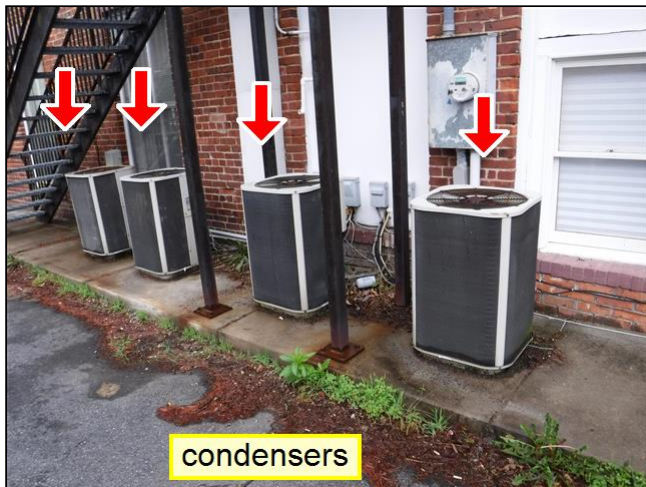
7.3 Item 3(Picture)

(2) The exterior condensers appeared to be in good condition.

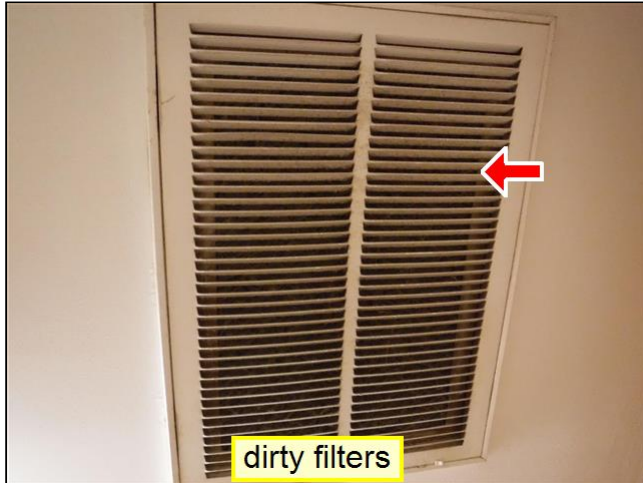
7.4 Item 1(Picture)

The filters were dirty. Recommend repair by a qualified person in this field.

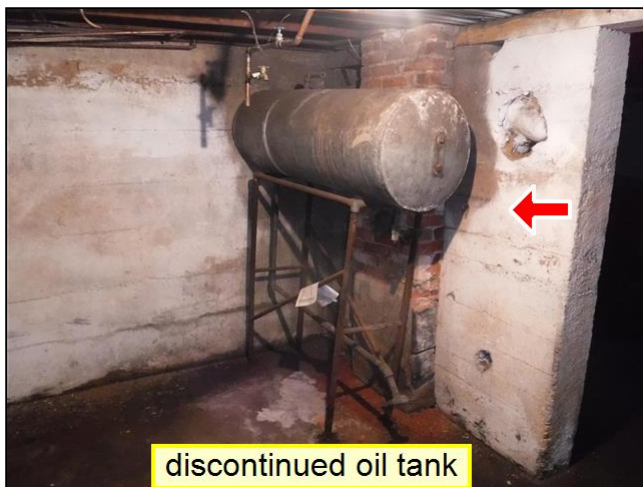
7.6 Item 1(Picture)

(1) There is a discontinued oil tank in the basement.

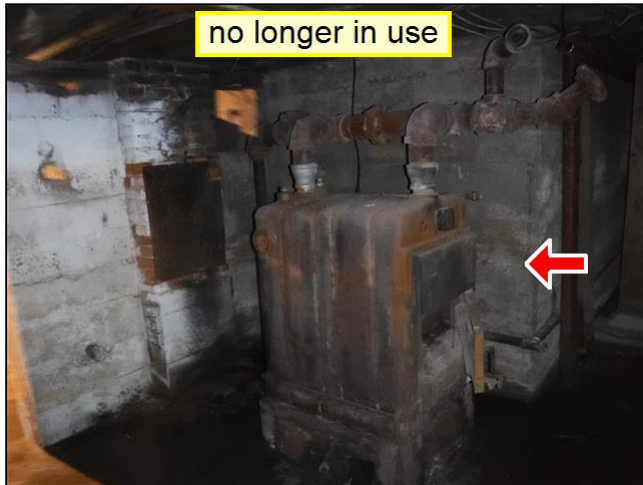
7.6 Item 2(Picture)

(2) There were two other items in the basement that are no longer in use. One appeared to be part of an old boiler and the other item I don't know what it is or was.

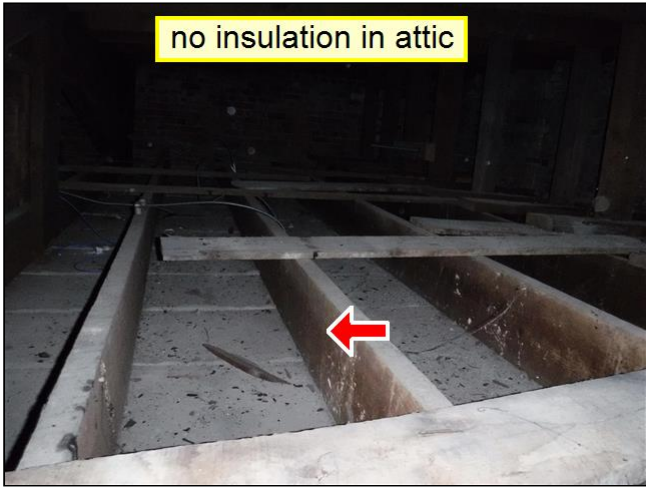
8.0 Item 1(Picture)

**Comments:** Not Present  
No insulation was noted in the attic.

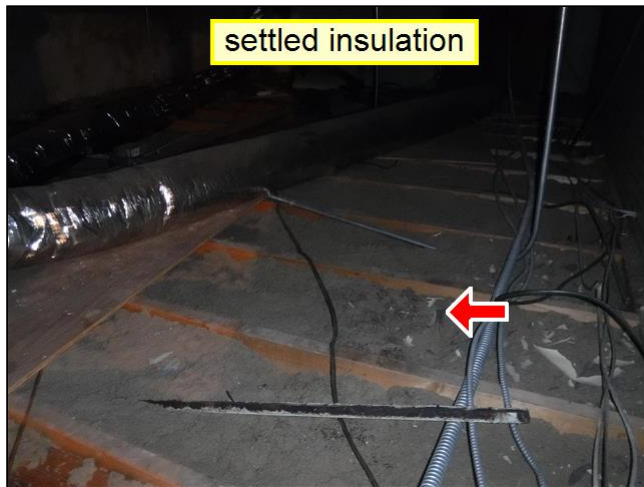
8.1 Item 1(Picture)

**Comments:** Inspected  
(1) Typically this era home has no insulation in the crawl space.

(2) Insulation between floors has settled over time. Adding insulation in the attic will help with energy efficiency.

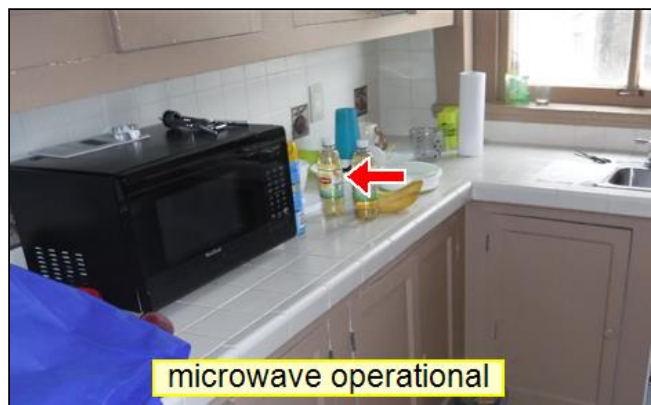
9.0 Item 1(Picture)

**Comments:** Inspected  
The counter top microwave was tested and operational.

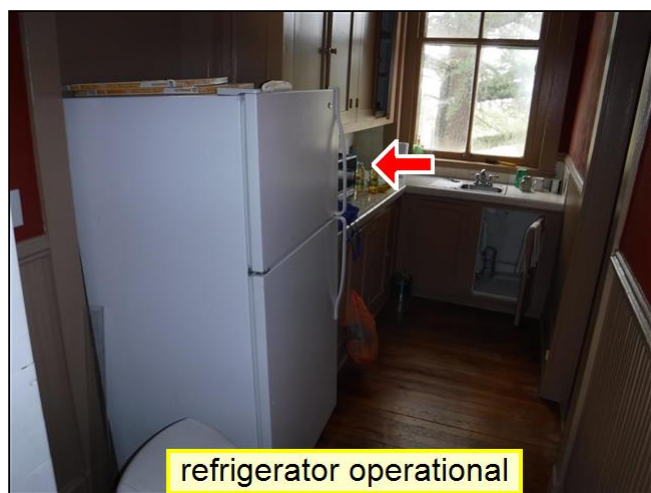
9.1 Item 1(Picture)

**Comments:** Inspected  
The refrigerator / freezer was working fine at the time of the inspection, and the ice maker was making ice.

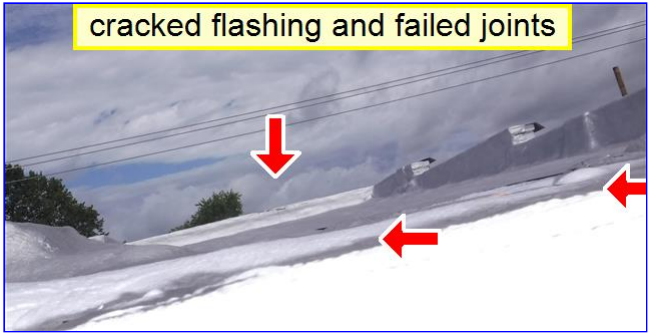
1.0 Item 1(Picture)

- (1) The flat roof has been coated with a white material. There are areas that appear to have failed in the roof coverings. The flashing is also cracked at the front of the building. Recommend evaluation and repair by a licensed roofing company.

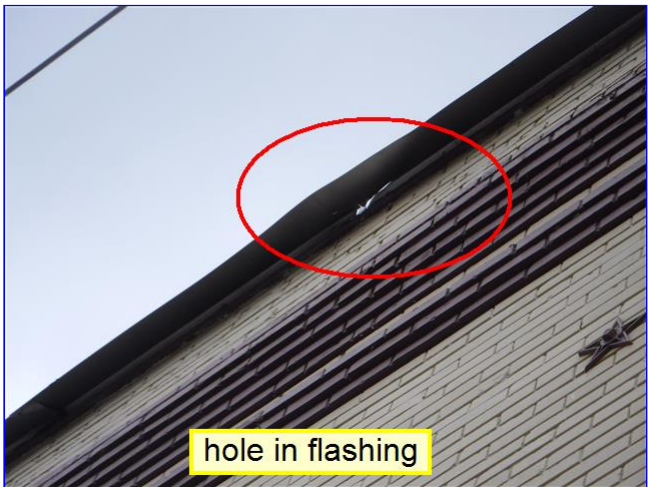
1.1 Item 1(Picture)

The hole in roof flashing as viewed from the ground. Recommend repair by a licensed roofing contractor.

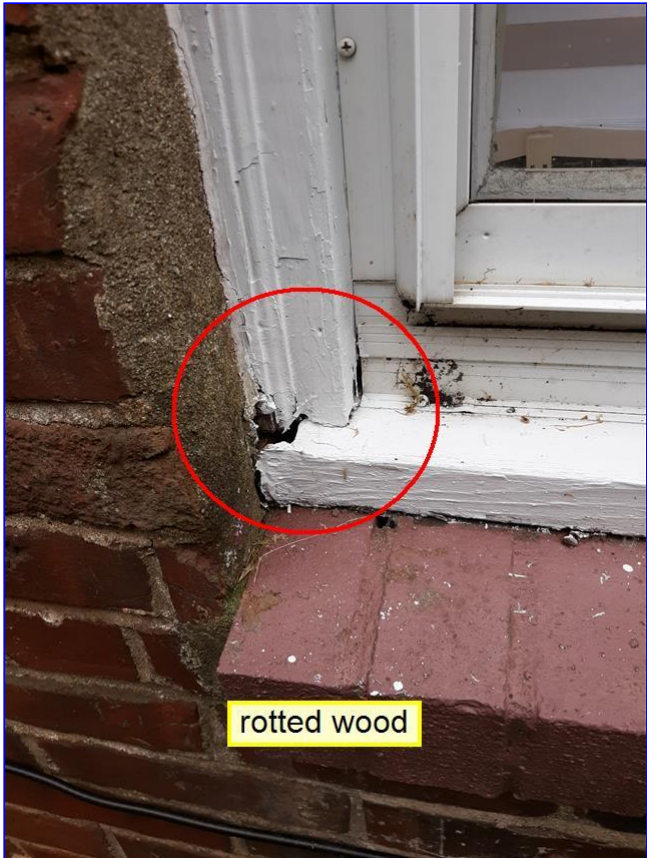
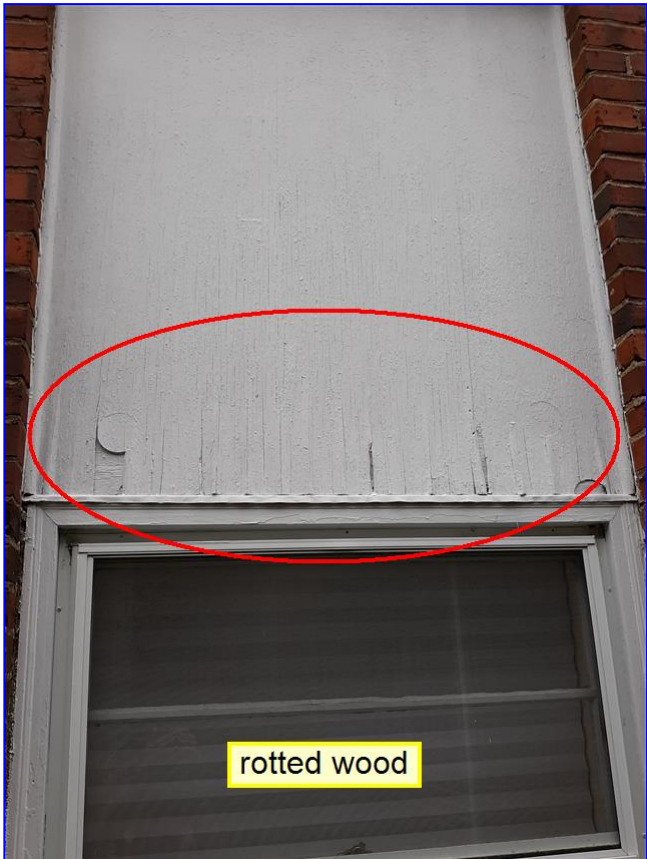
2.0 Item 1(Picture)

(1) There is rotted wood trim and wood siding on the left exterior of the building and the back window. Recommend repair by a qualified contractor in this field.

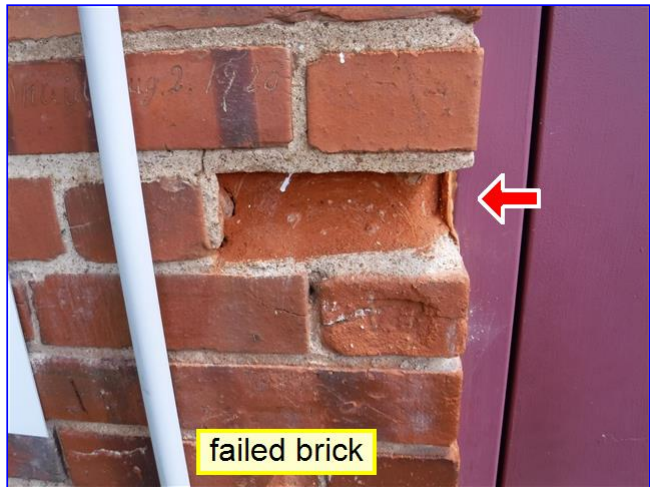
2.0 Item 5(Picture)

(2) There is a failed brick by the side door. Recommend repair by a qualified contractor in this field.

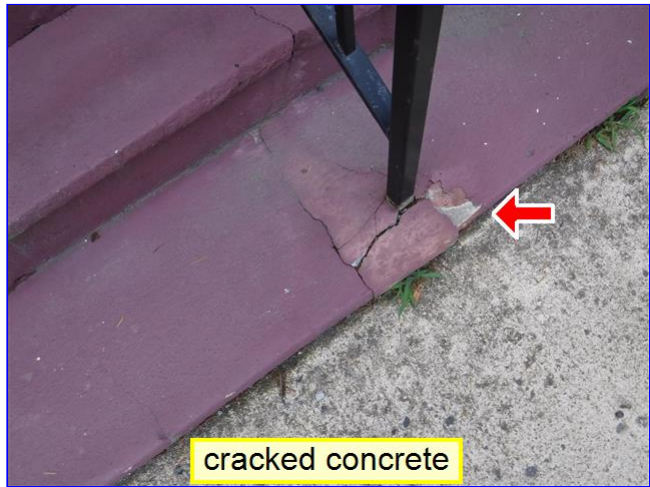
2.3 Item 1(Picture)

There is cracked concrete at the front entrance. Recommend evaluation and repair by a qualified contractor in this field.

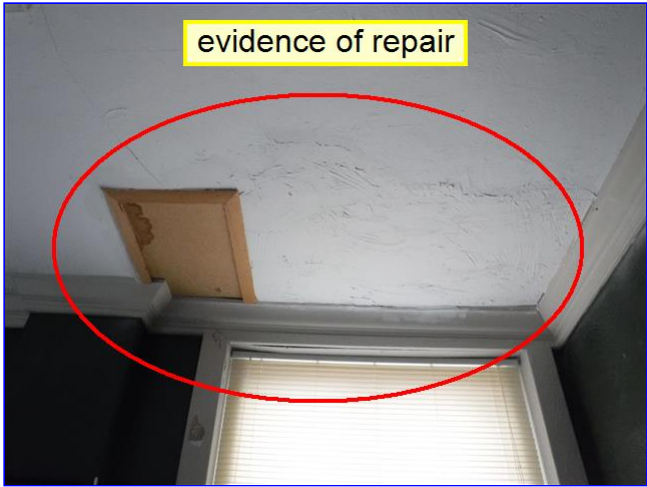
3.0 Item 1(Picture)

(1) There is evidence of a repair in the ceiling. Recommend evaluation and repair if needed by a qualified contractor in this field.

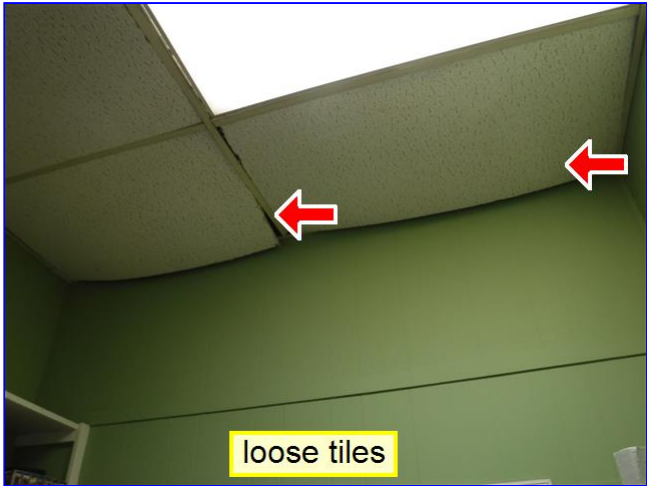
3.0 Item 2(Picture)

🏠 (2) There are degraded and loose ceiling tiles in the hallway. Recommend repair by a qualified contractor in this field.

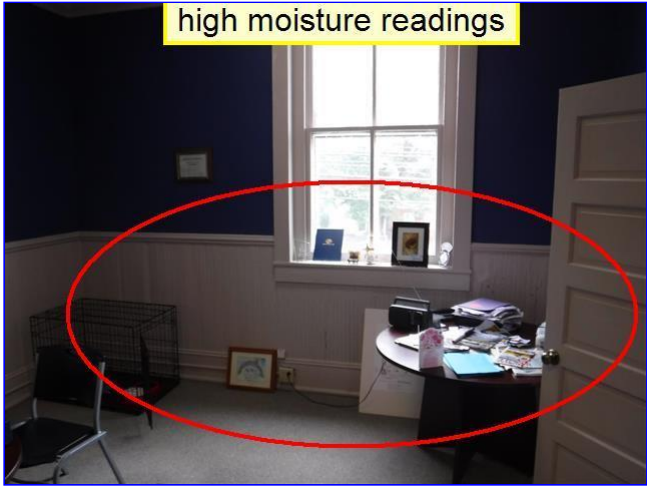
3.1 Item 1(Picture)

🏠 (1) The upstairs front wall (main office) has a very high moisture content in the wall. Recommend evaluation and repair by a qualified contractor in this field.
